INEEL/CON-01-01450
PREPRINT

Underground Corrosion of Activated Metals in an Arid Vadose Zone Environment

NACE 2002

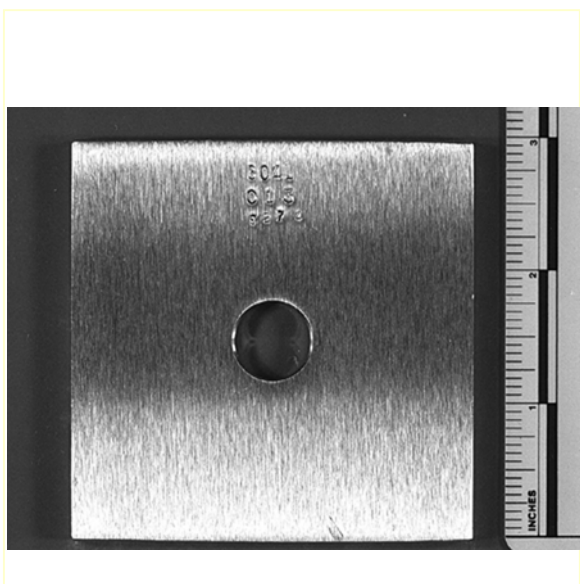
FIGURE 1. 304L stainless steel coupon.

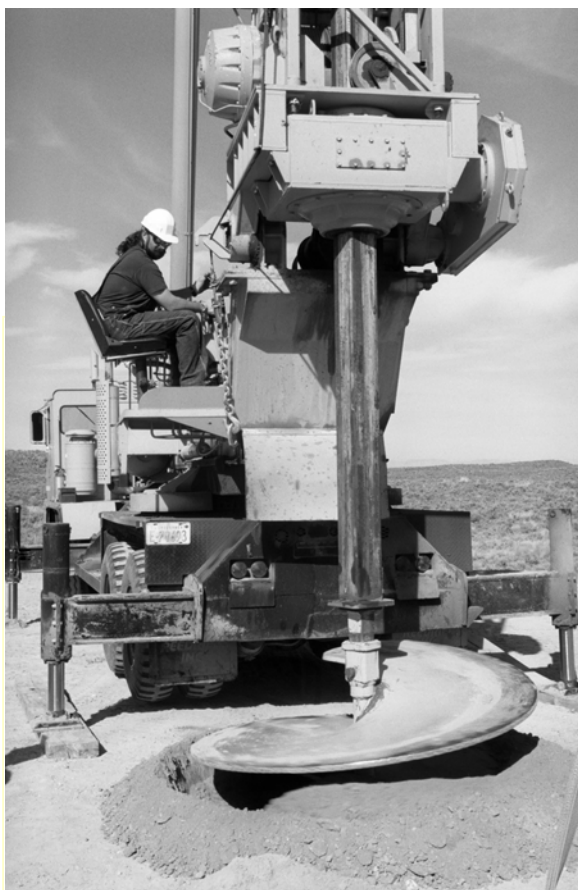
FIGURE 3. 6-ft diameter auger drill.

The long-term corrosion testing began in 1997 when a berm was constructed near the underground disposal site to test corrosion rates at two distinct depths: 4 ft (1.22 m) below surface and 10 ft (3.05 m) below surface. A 6-ft (1.83-m) diameter auger (see Figure 3) was used to drill holes in the berm for placement of the coupons. The coupons were installed as arrays, each consisting of a set of 36 coupons (four samples of each metal type) assembled on polypropylene rods with polytetrafluoroethylene (PTFE) tubing as spacers between coupons. Polypropylene and PTFE were selected because these materials are chemically inert and will electrically isolate the coupons from each other. Each end of the polypropylene rod has engraved PTFE identification markers and is secured with a threaded nylon nut. A coupon array (see Figure 4) was placed at each depth at four locations.

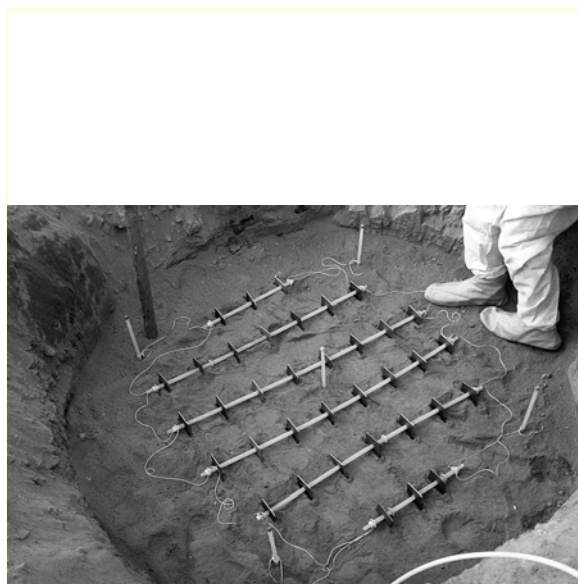
FIGURE 4. Coupon array.

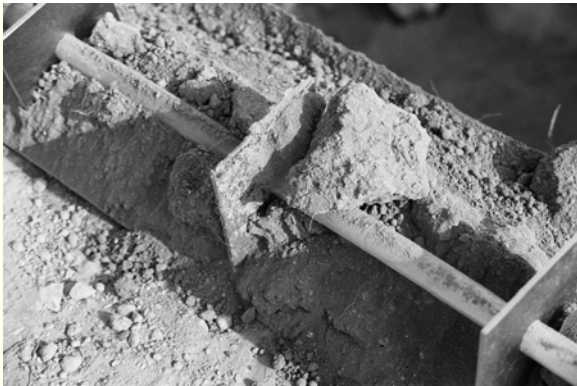
FIGURE 5. Carbon steel coupon on rod.

coupons were extracted carefully from the hole, with care not to lose the adhering soil around them (see Figure 5). The excavated coupons were double-bagged (see Figure 6) and transported to the appropriate laboratory and disassembled, and the corrosion products, including the potential presence of microorganisms, were sampled.

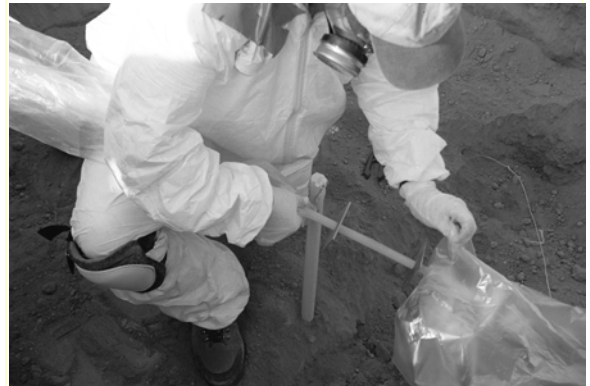
FIGURE 6. Double bagging coupons.

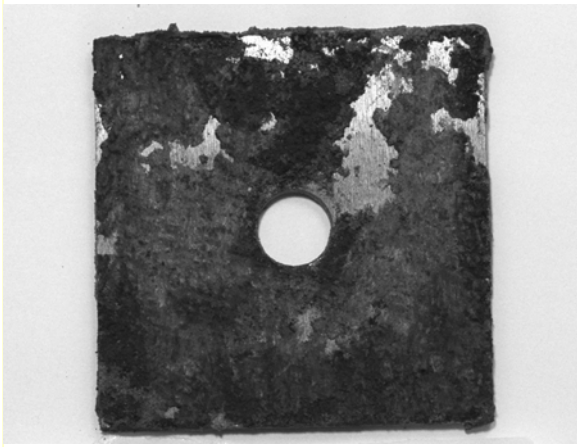
FIGURE 7. Carbon steel front - uncleaned.

The aluminum, beryllium, and carbon steel coupons all experienced pitting to some degree. Figures 7 and 8 are photographs of the front and back of a carbon steel coupon before cleaning (from the 10-ft (3.05-m) depth), and Figures 9 and 10 show the same specimen, front and back, after cleaning. Likewise, Figures 11 and 12 are photographs of the front and back of a beryllium coupon before cleaning (from the 10-ft [3.05-m] depth). Figures 13 and 14 show the same specimen, front and back, after cleaning. Pitting was evident in three metal types: aluminum, beryllium, and carbon steel. Table 3 details the pit depth measurements from six coupons with visibly deep-pitted surfaces.

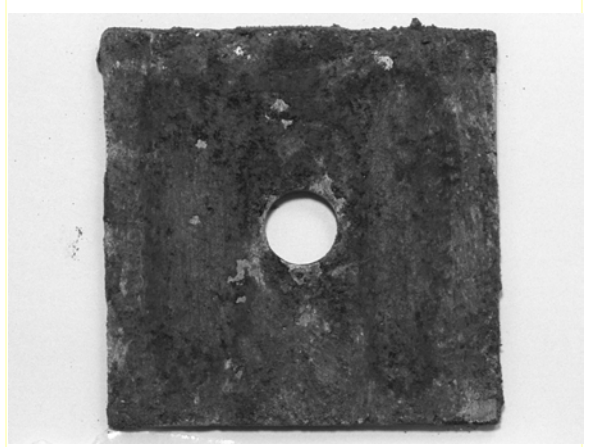
FIGURE 8. Carbon steel back - uncleaned.

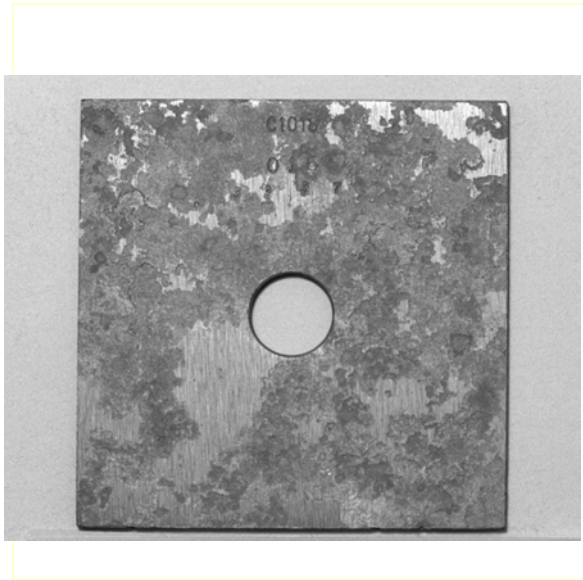
FIGURE 9. Carbon steel front - cleaned.

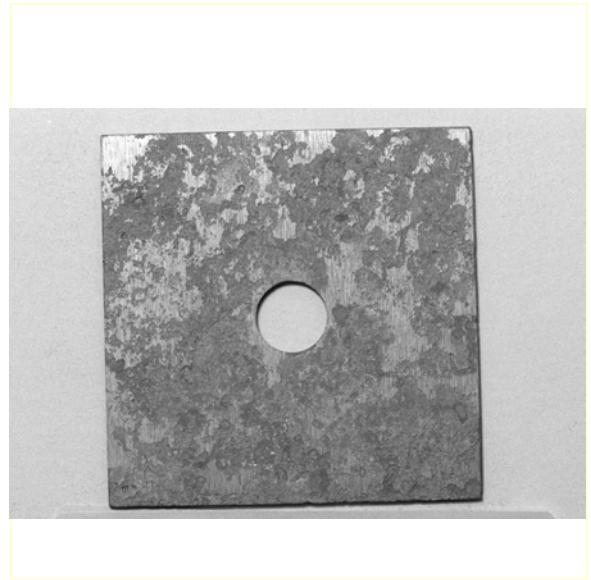
FIGURE 10. Carbon steel back - cleaned.

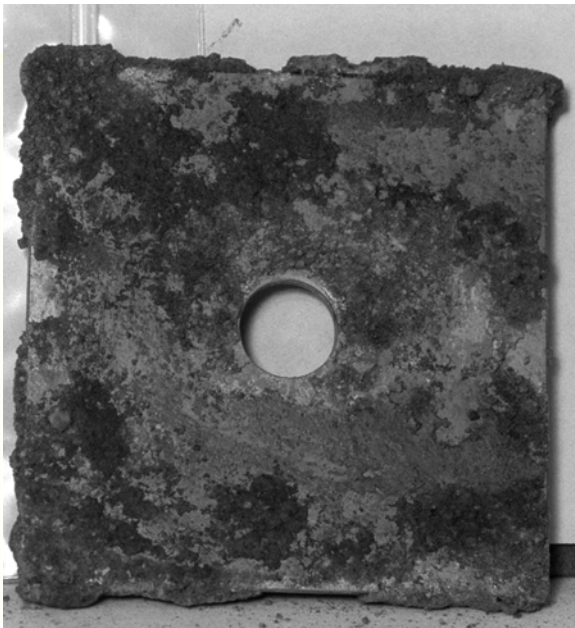
FIGURE 11. Beryllium front - uncleaned.

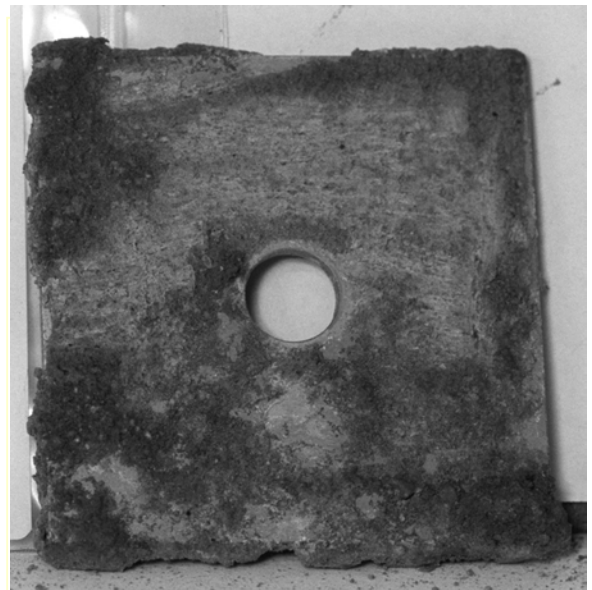
FIGURE 12. Beryllium back - uncleaned.

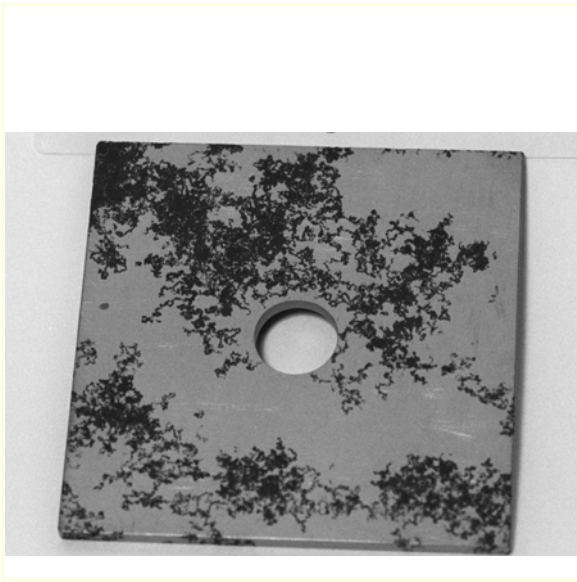
FIGURE 13. Beryllium front - cleaned.

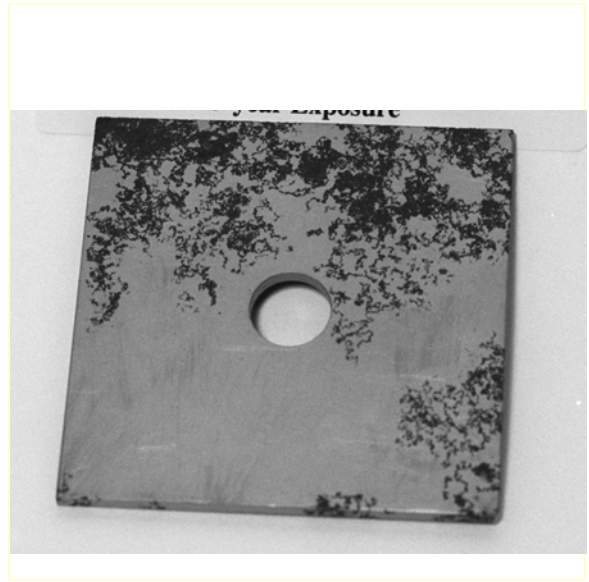
FIGURE 14. Beryllium back - cleaned.
